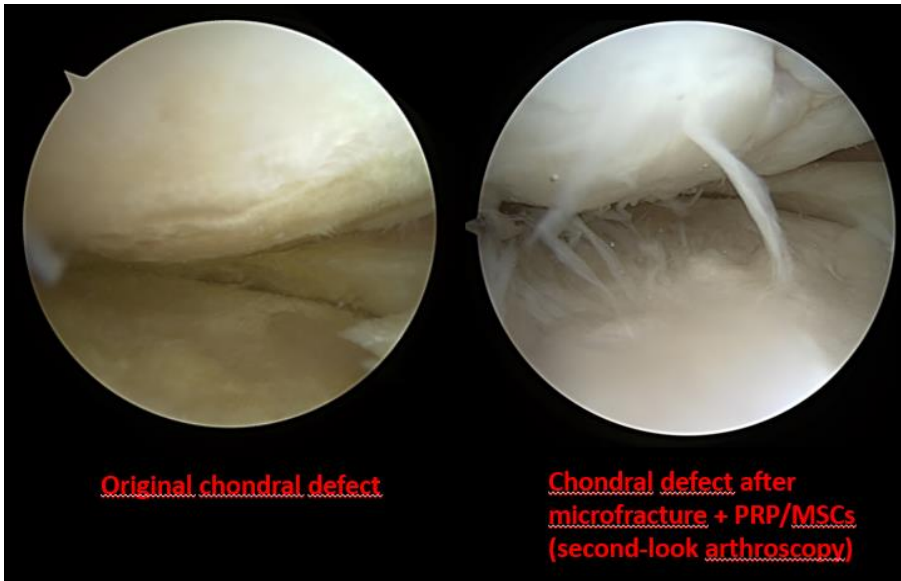
Fig. 4. *Macroscopic evaluation of the cartilage lesion – original chondral defect compared with the same lesion after microfracture + PRP/MSCs (as detected during a second-look arthroscopy). A bioptic sample was harvested for histological evaluation.*
